**DESIGNATED SUBSTANCES SURVEY
2502-601**

**4428 Old Kingston Road
Portland, Ontario**

March 12, 2025

Skootamatta
Environmental Consulting Inc.

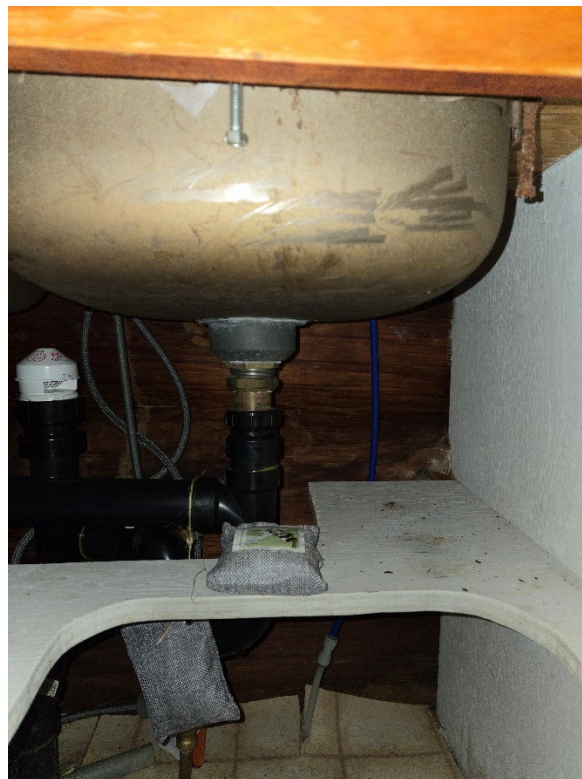
Chrysotile asbestos was detected in the black glaze that was found on the under side of the sink in the kitchen.

Picture 2: Under side of the kitchen sink. The glaze contains 1% chrysotile asbestos.

When presence of asbestos containing material is confirmed an Asbestos Management Plan must be implemented, unless the material is removed. The Asbestos Management Plan includes building drawings that depict where the asbestos containing material is located. An annual inspection of the area is to be completed to ensure that there are no damages to the area where the material is located. If asbestos containing material happens to be damaged, repairs should be made immediately so as to decrease the amount of potentially airborne asbestos fibers. It is the owner's responsibility to provide any contractor, worker or resident of the building with information of the asbestos that is present as per Ontario Regulation 278/05 "Designated Substance – Asbestos on Construction Projects and in Buildings and Repair Operations".

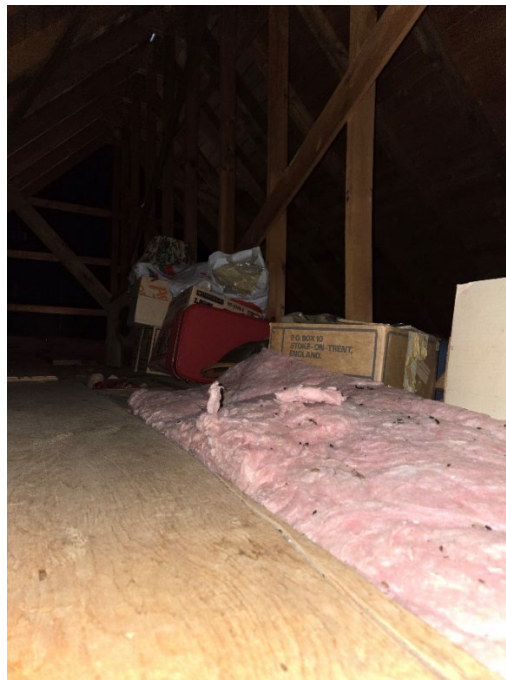
Picture 3: The attic contained fibreglass insulation.

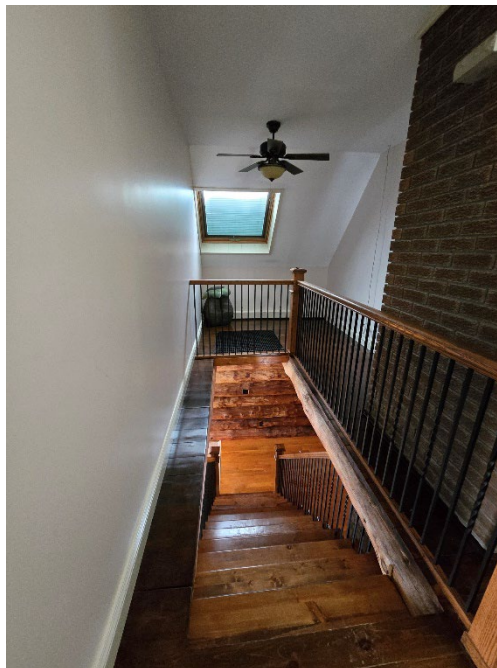
Water damage was observed around the skylight and along the joint between the wall and ceiling in the south west bedroom on the second floor of the house. The extend of the water damage is not known.

Picture 4: The sky light on the second floor that has evidence of past water damage.

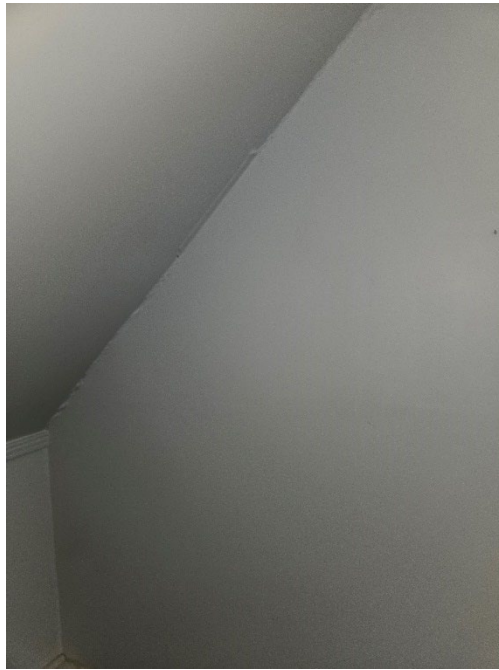
Picture 5: Evidence of water damage on the second floor south west bedroom.
